AFFDL-TR-79-3118
Volume III

DURABILITY METHODS DEVELOPMENT
VOLUME III
STRUCTURAL DURABILITY SURVEY:
STATE-OF-THE-ART ASSESSMENT

B. J. PENDLEY
S. P. HENSLEE
S. D. MANNING
GENERAL DYNAMICS CORPORATION
STRUCTURAL AND DESIGN DEPARTMENT
FORT WORTH DIVISION
FORT WORTH, TEXAS

TECHNICAL REPORT AFFDL-TR-79-3118, VOL. III

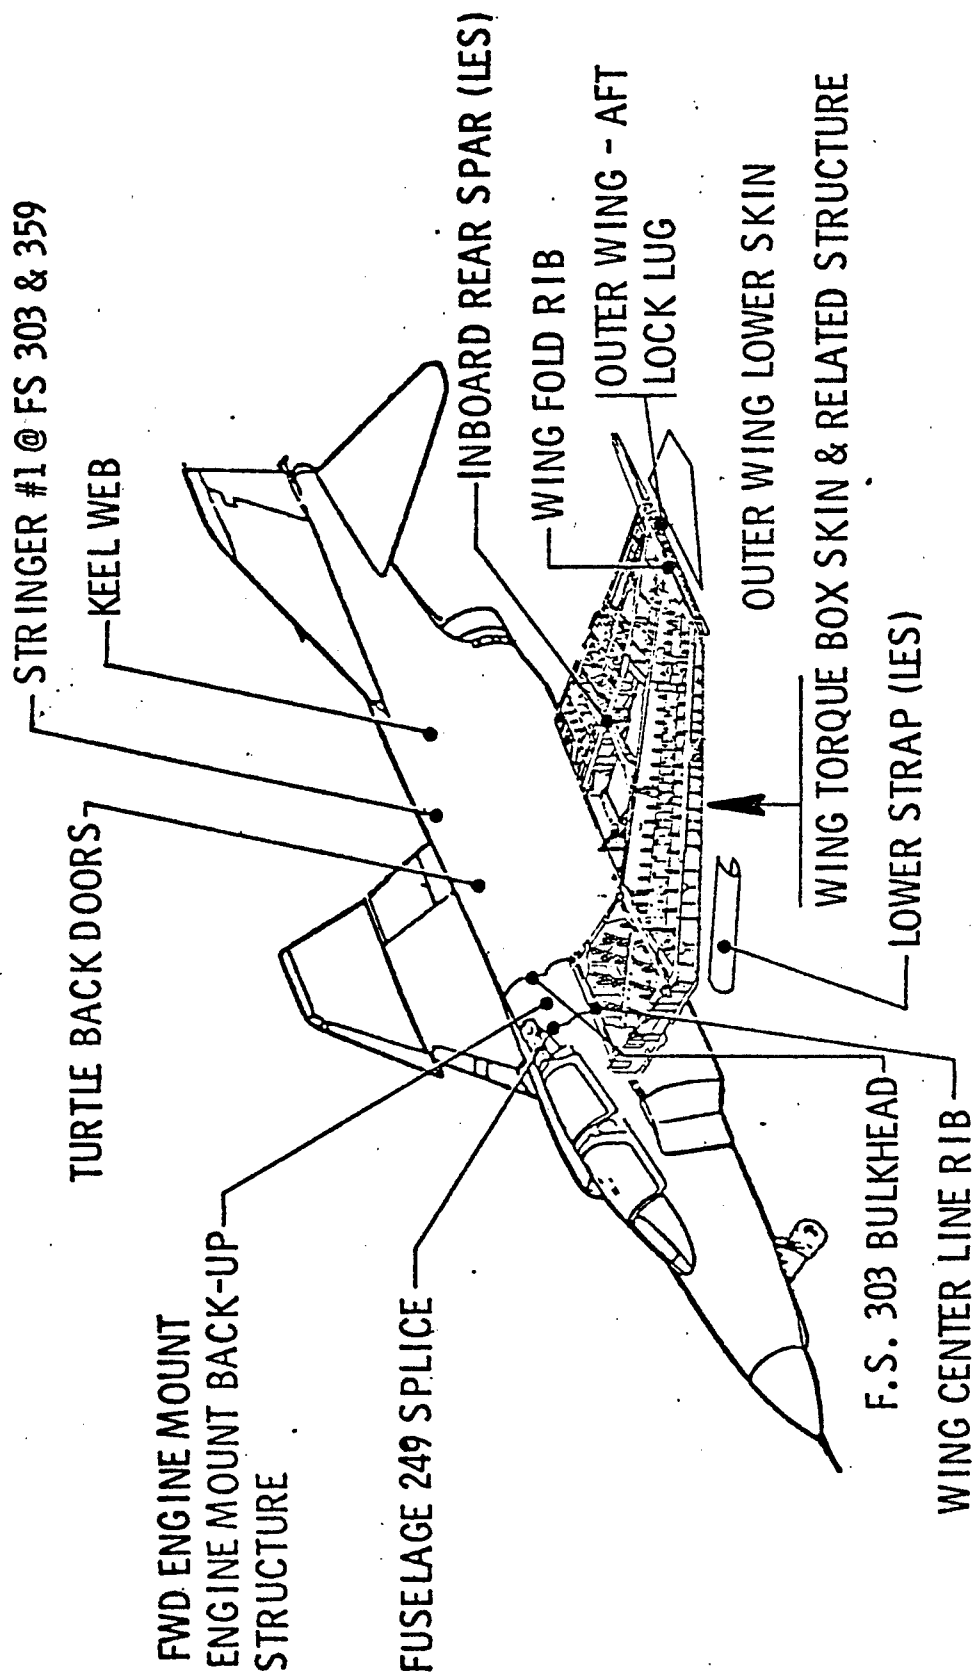
FIGURE 6 F-4 Significant Test Failures

Significant test and service failures are summarized in Figures 6 and 7, respectively. Service failures attributed to stress corrosion are shown in Figure 8.

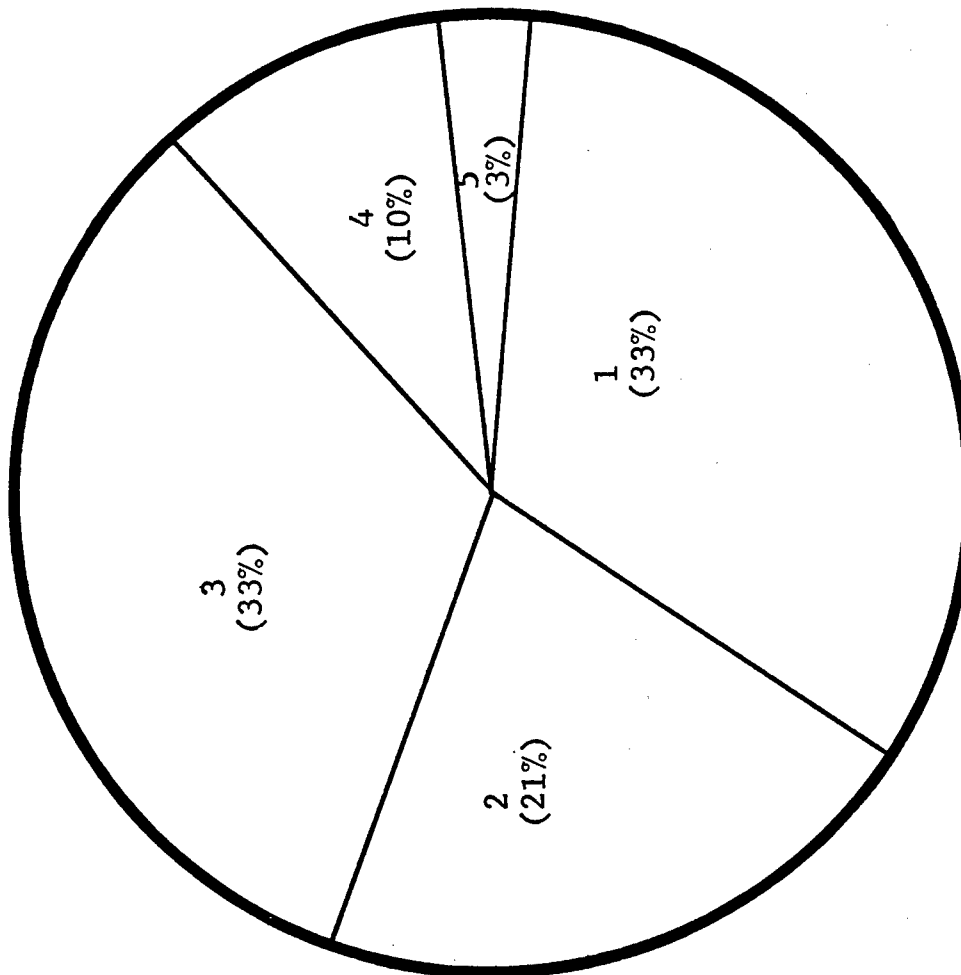
FIGURE 16 F-16 Durability Airframe Test Results
For 1st 8000 Hour Life

61 TEST FAILURE INCIDENTS
(1st 8000 HOUR SERVICE LIFE)

NOTE: All Parts Experiencing Cracking Were Redesigned For Production Configuration

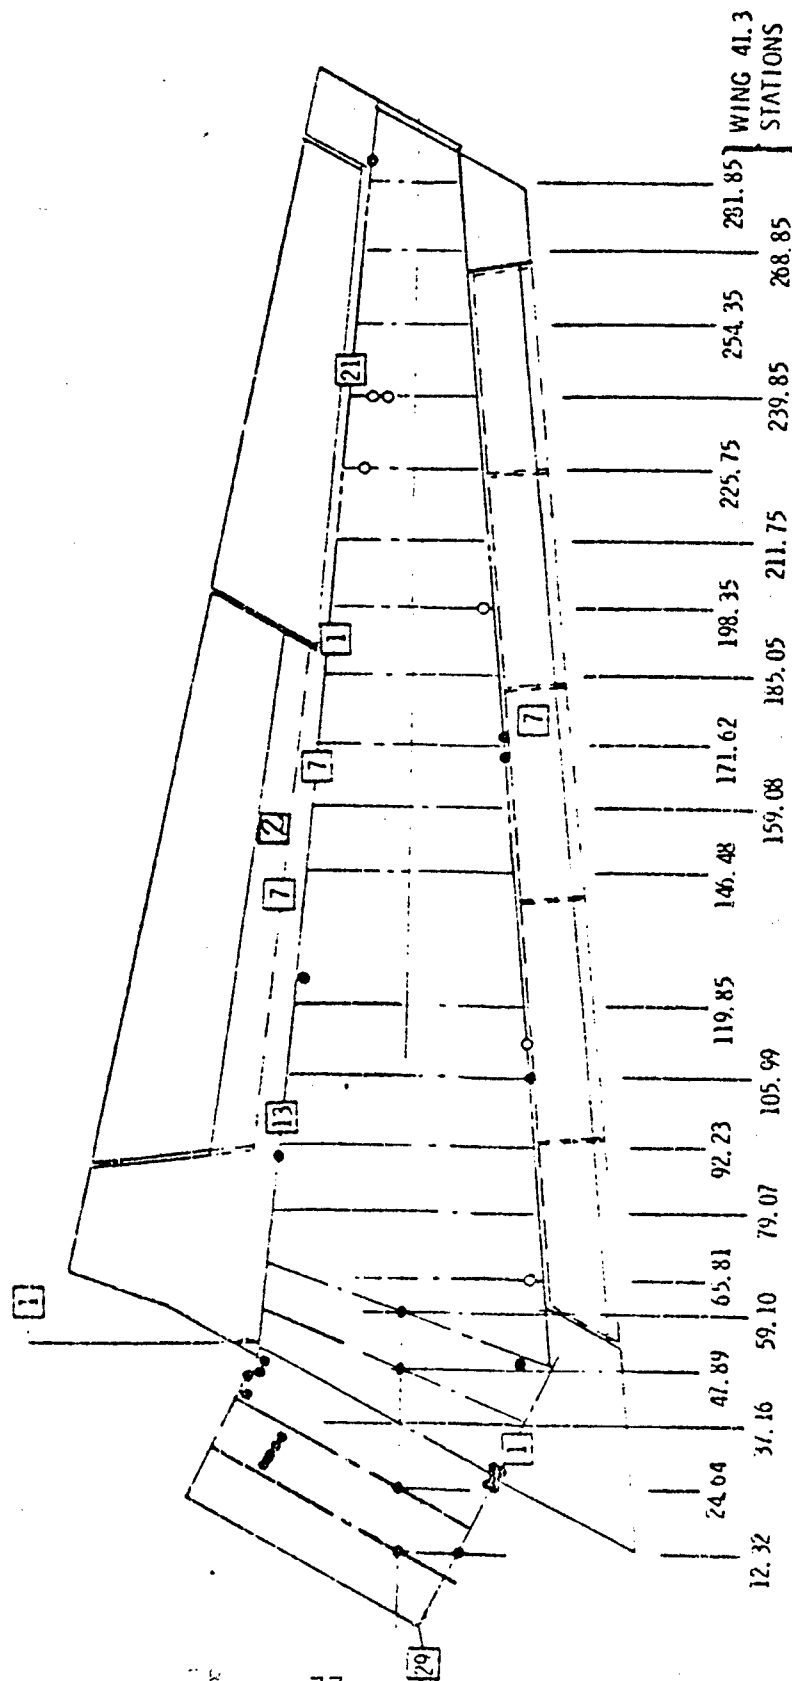
FIGURE 27 T-39A Left Wing Crack Distribution - Service & Test

- [xx] 89 FIFT CRACKS IDENTIFIED DURING REMAN PROGRAM ON 130 T 39A AIRCRAFT.
 - IWR SURF } CRACKS IDENTIFIED AT TEST TERMINATION
 - UPPER SURF } & TEARDOWN X (S.L.E.P. TEST)
- TOTAL CRACKS = 26

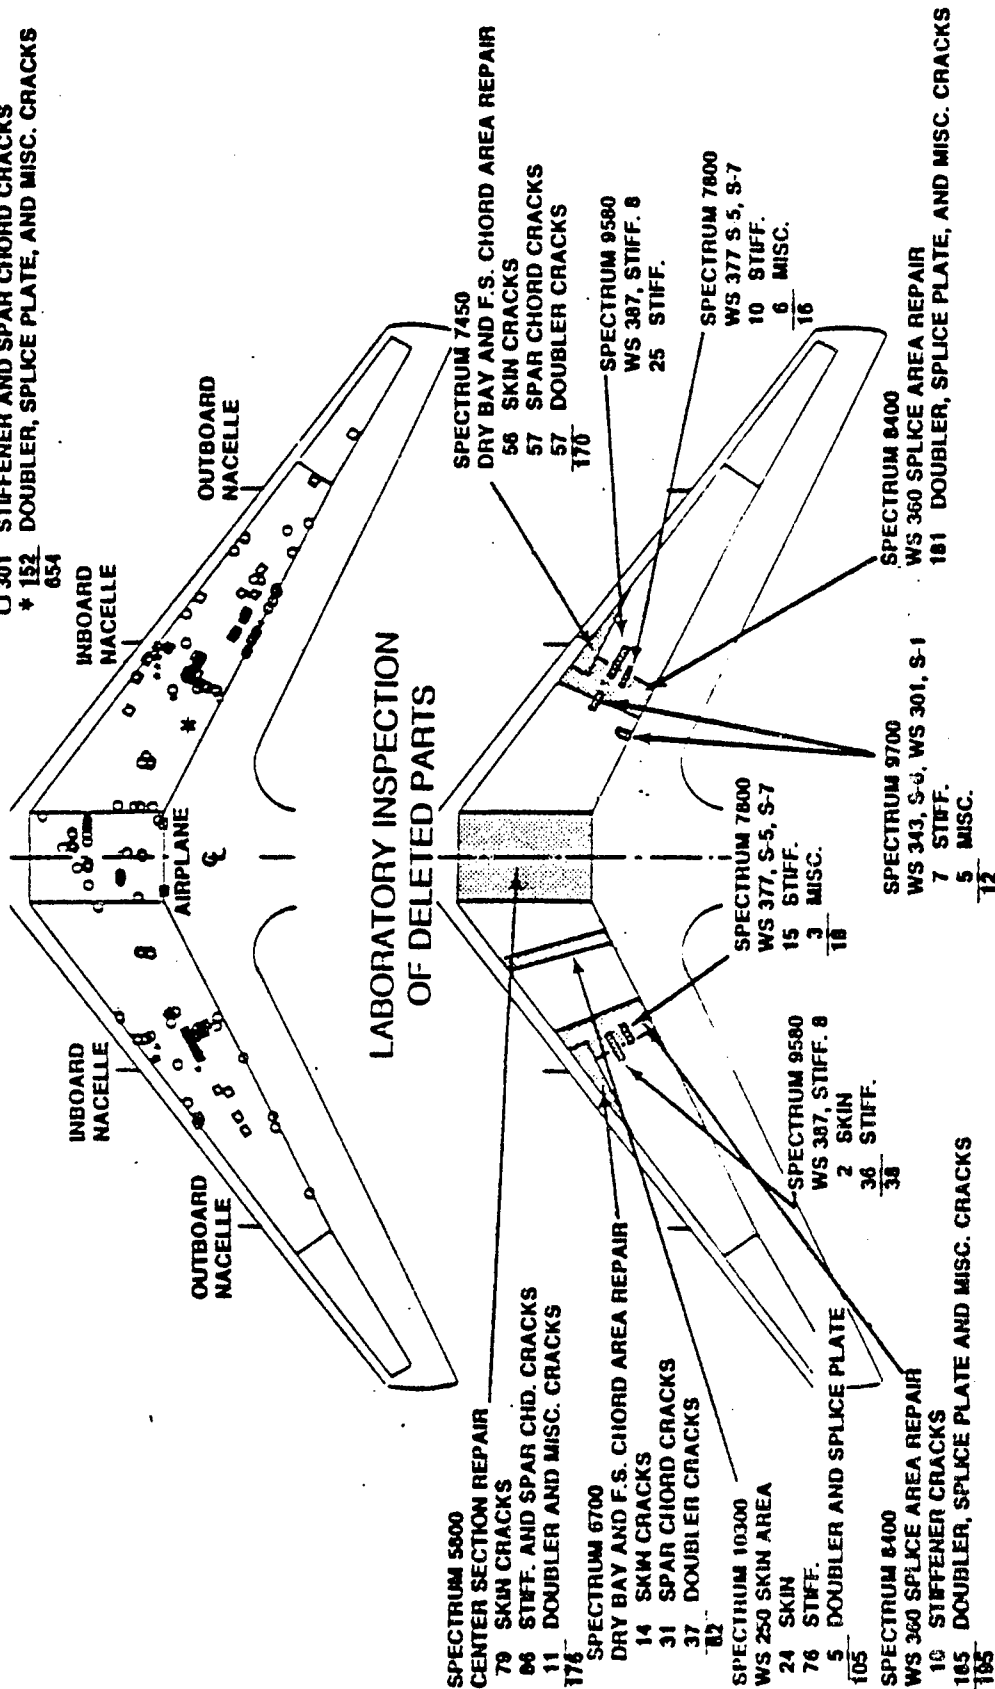
FIGURE 37 KC-135 Wing Lower Surface Fatigue Summary

- O 201 SKIN CRACKS
- O 301 STIFFENER AND SPAR CHORD CRACKS
- * 152 DOUBLER, SPLICE PLATE, AND MISC. CRACKS
- 654

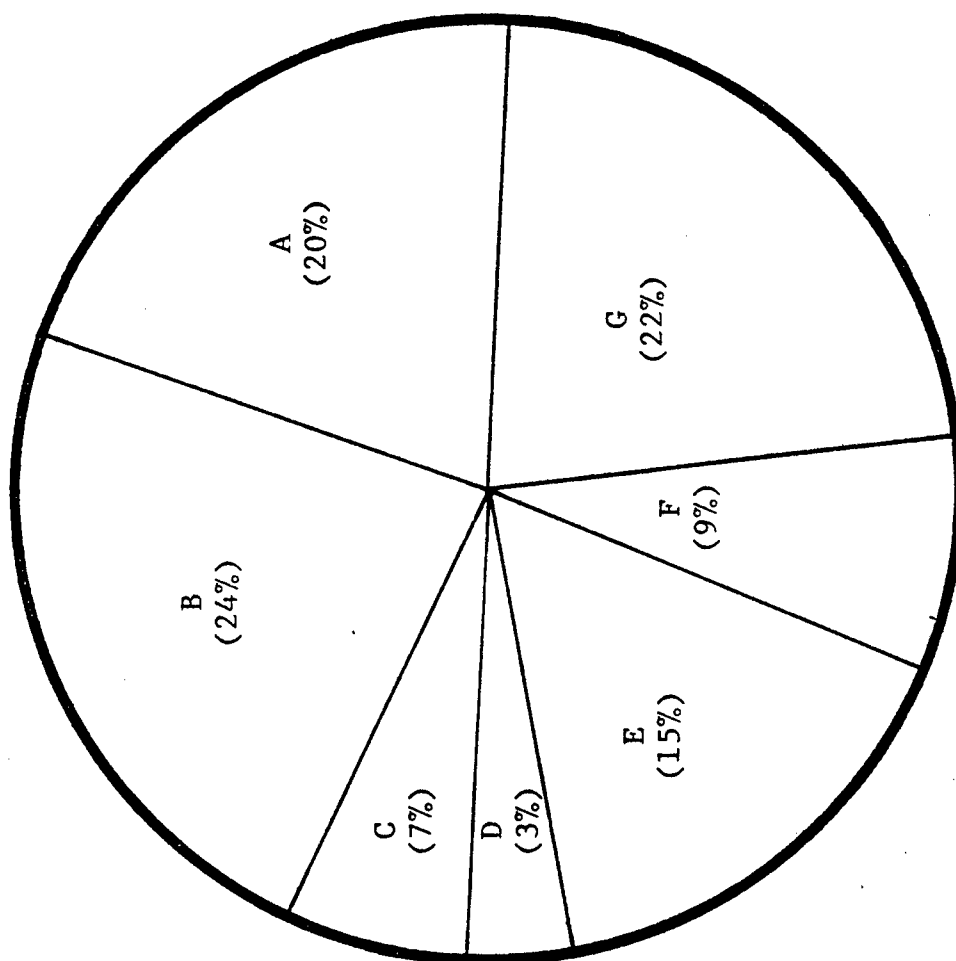
DETAIL - MINOR INCIDENTS

- A 12 Incidents of Corrosion,
- B 14 Incidents Loose, Missing, And/Or Damage Fasteners
- C 4 Incidents Ruptured Lines
- D 2 Incidents of Punctured Honeycomb Panels/Doors.
- E 9 Incidents of Elongated Holes
- F 5 Incidents of Cracks/Scratches
- G 13 Other
